# mainair sports

TRI-FLYER - GENERAL BULLETIN No. 9

25th August, 1983

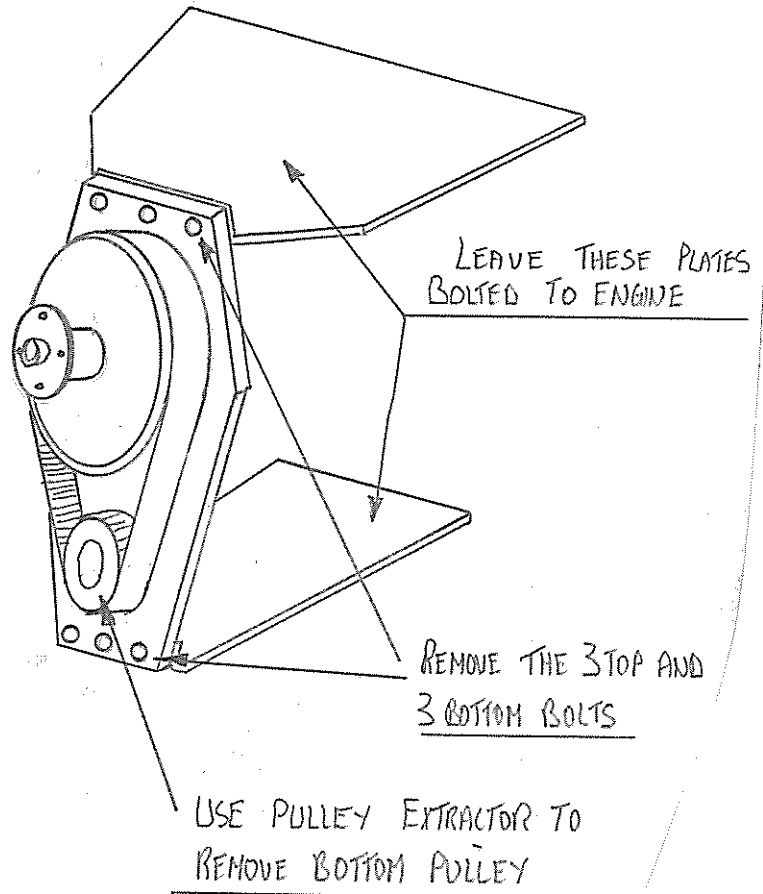
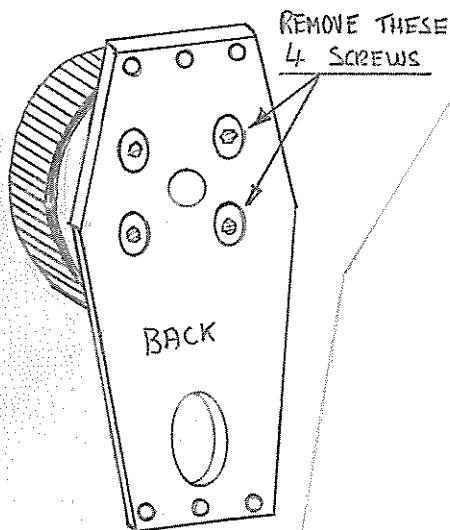
**FAULT** The bearing hub unit required greasing at 10-hour intervals. Unfortunately our sealed bearings are passing grease and will eventually fail.

1. Detach front plate by removing the 3 top and 3 bottom bolts. Remove bottom pulley with pulley drawer.

2. Reverse plate and remove the 4 countersunk screws with the key provided
