TITLE	Internal aileron and flap bracket inspection and replacement.
CLASSIFICATION	The CAA have classified this bulletin as Mandatory.
COMPLIANCE	Within the next 5 hours.
APPLICABILITY	All CT2K aircraft manufactured and UK Registered prior to 1 May 2004.

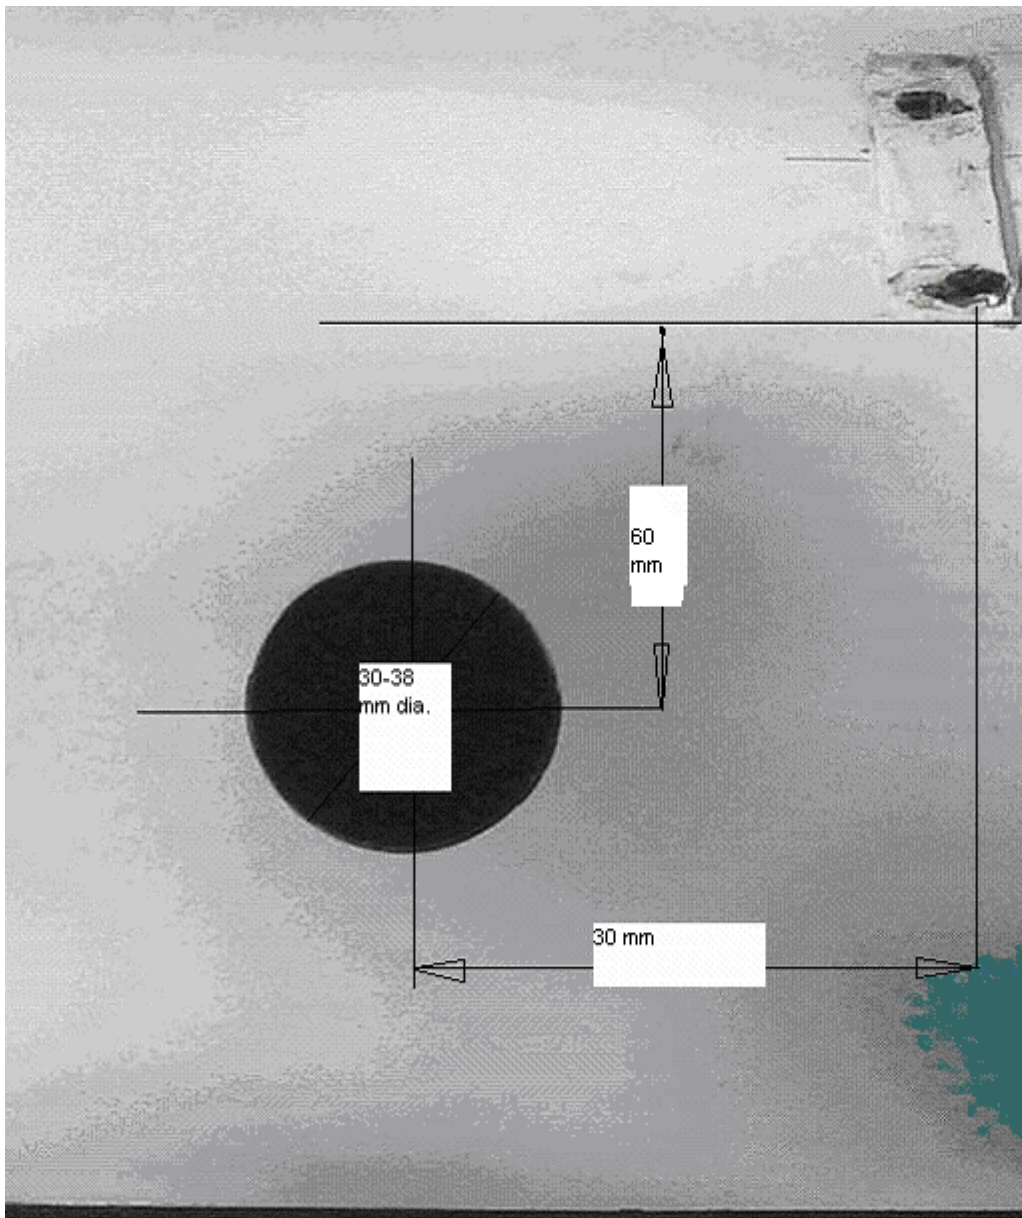
Fig. 1 inspection hole in wing trailing edge, inboard of bracket skin holes. Wing shown upside down.

Within the next 5 hours, on both wings, an inspection hole must be made at the mid-flap bracket and outboard aileron bracket locations as detailed in fig 1 below. For the combined outer flap/inner aileron bracket, the aileron pushrod hole enables inspection. Using a mirror and torch, the internal bracket feet can be inspected.

- 1) Remove ailerons and flaps by detaching the hinge bolts and aileron pushrod. It is generally easiest to remove the aileron pushrod at the wing bellcrank.
- 2) At the outer aileron bracket and mid flap bracket locations on both wings, Using a fine toothed holesaw, drill an inspection hole $\text{Ø}30 - 38\text{mm}$, at the sloping face of the wing trailing edge, 30mm $\pm 5\text{mm}$ inboard from the bracket holes and 60mm $\pm 5\text{mm}$ along the surface from the bottom of the bracket (fig.1).

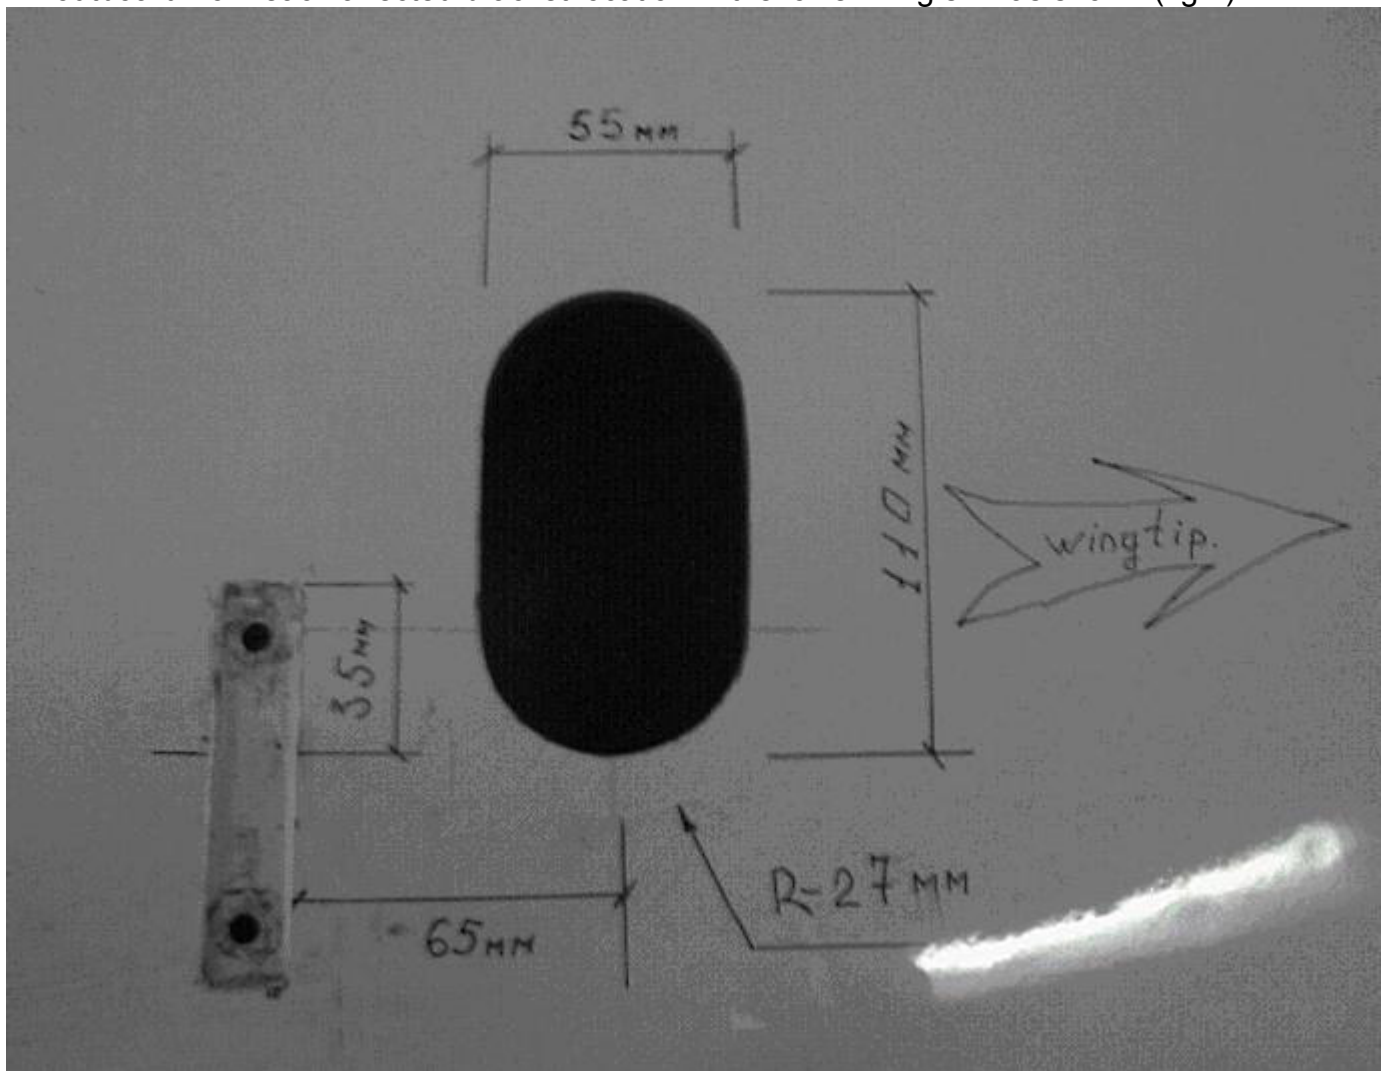
Fig. 2 access hole in wing lower surface, outboard of bracket skin holes

1. Using a holesaw and diamond wheel or fine toothed saw, Cut out an access hole outboard from each affected bracket location in the lower wing skin as shown (fig.2).
