**SERVICE BULLETIN NUMBER CT124**

**TITLE** Flap up limit cable  
**CLASSIFICATION** The CAA have classified this bulletin as Mandatory.  
**COMPLIANCE** Inspection before further flight;replacement within 5 hrs if affected.  
**APPLICABILITY** All CT2K up to Flight Design serial no. 03-07-03-34, P&M serial 8124 inclusive.

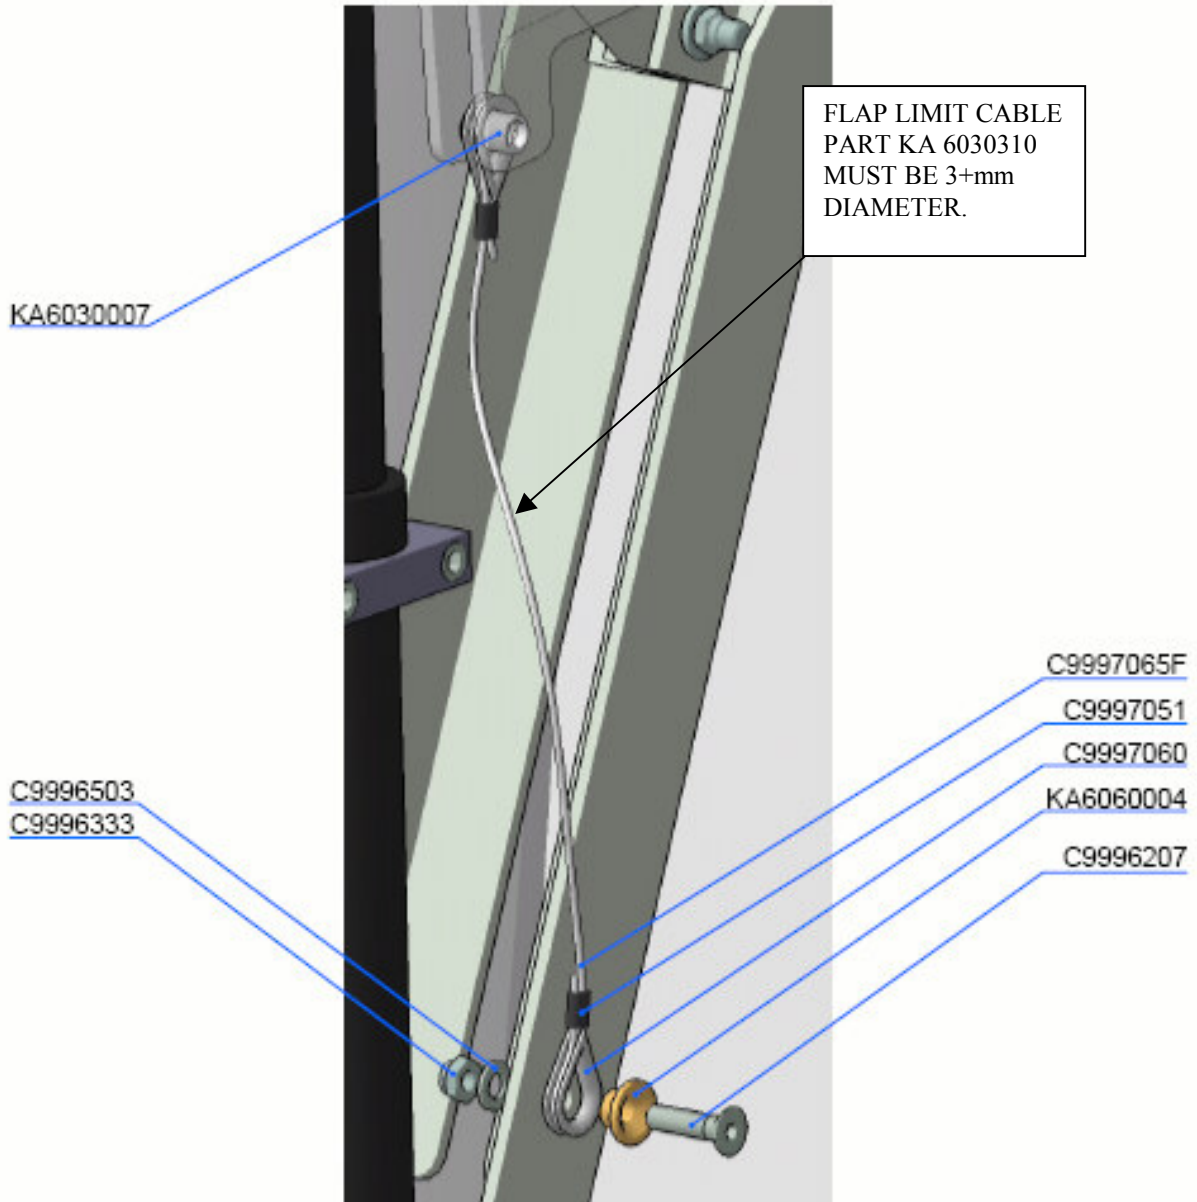
Fig 1. Limit Cable Installation

The electric flap system on the CT2K is provided with a flexible steel cable which limits the UP flap travel in the event of failure of the limit switch. Some examples of CT2K were manufactured with a 1.5mm strop which can break under some circumstances, if the limit switch fails.

In the event of failure of the UP flap limit switch, it has been found that although the flap motor circuit breaker will trip when run against the 1.5mm cable, subsequent repeated selection of UP flap will cause the cable to break. The flaps will then run beyond the normal -12° setting until stopped by the motor internal stop. More than -12° flap setting reduces performance and increases stall speed.

Before further flight, inspect the flap UP limit cable and measure the diameter using a vernier calliper. It should be 3 – 3.5mm. See fig 1.

If a smaller cable is installed, it must be replaced within the next 5 flying hours. The cable length is set up on each individual aeroplane to allow for production build tolerances.

If the cable is too small, it must be replaced with a new cable part. KA 6030310 according to modification M109. Provided the flap system is working normally and the flaps UP position is stopped by the limit switch and not the cable, it is permissible to ferry fly the aeroplane to P & M or a P & M approved facility to enable the modification to be carried out. Alternatively the cable should be removed and sent by recorded delivery to P & M Aviation Ltd, where a new 3mm cable assembly part. KA 6030310 will be made up to match it.

When the cable is replaced, a full functional check of the flap system must be made, including deflection according to TADS BM65 (UP -60mm +-5, DOWN +175mm +-10, relative to fuselage fillet trailing edge), limit switch operation, LED indications and flap symmetry.
