1. Accidents Previous bulletins have outlined serious structural failure accidents, and despite extensive investigations we are still unable to state categorically what happened. However, reasonable assumptions, based on witness reports and the examination of the structures, allows us to guess with some certainty as to what is going wrong.

26th. November, 1987.

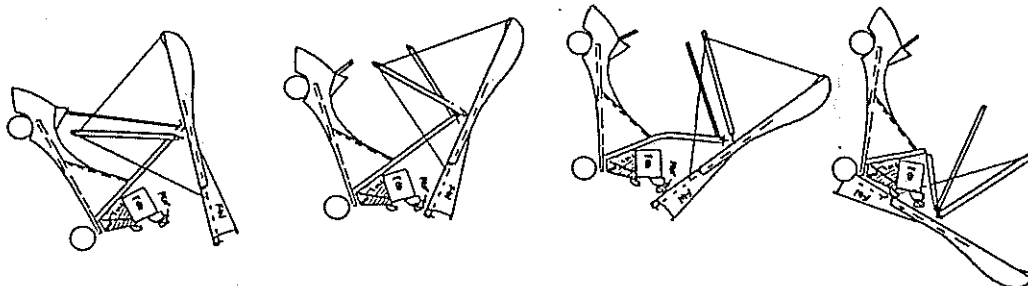
Roll accidents. Witness statements point conclusively to the aircraft being operated outside the designed and tested flight envelopes in the two roll induced accidents. Quoted bank angles vary from: "60°", "80°", "90° and more", "85°" to "excessive flying" "spectacular flying", "very, very steep banks", after which the aircraft was rolled to a similar bank the opposite way to conduct a figure 8 manoeuvre. At this point the roll continues and we suspect a negative load is applied to the wing which, because of the sweep and extremely positive pitching characteristics, causes the wing to 'arc' away from the trike unit with devastating force. The bar is snatched from the pilot's hands and smashed through the front strut. The rest is inevitable. The following simplistic diagram will illustrate the sequence:

The aircraft all showed signs of severe negative loading supporting the above. Leech lines torn out and strained, battens bent and broken, propeller and fuel tank contact marks on the wing fin and keel tube. Monopoles bent and broken rearwards, front struts bent and broken forwards, control bars bent and broken from impact with the front strut. The list goes on. However, although the sketch shows full inverted flight, look at it again as though from directly above in a plan view. It is perfectly feasible that the negative load could occur from a very fast, 90° to 90° roll reversal, as the low wing is rapidly accelerated sideways through the air to become the high wing.

To give you an example of the sort of forces involved, rig testing of the Flash wing at just 2½° of negative air flow caused the control bar to pull forward with a force of 175lbs at only 57 mph. Imagine the force at 70 mph or, say, 5° of negative air flow. There is just no way a pilot can remain hold of the bar. We believe trike inertia and poor piloting is behind the roll inversions. As the aircraft is flown from one steep bank to the other, the pilot is reacting against the trike unit, and unless he holds off the forces correctly, the inertia of the trike unit reacting against the wing can cause the bank to exceed that intended - perhaps up to 90° or more. If the air speed is decaying and the pilot then pulls in to get air speed - a natural reaction from an ordinary pilot - the result will be a further decay in airspeed, continuation of the roll and a negatively loaded wing.

The aircraft is not designed, tested or manufactured to be flown as an adrenalin or ego booster. It is not aerobatic. Do not show off, throw the aircraft around, put it through its paces or go out to prove a point. The bank angle of 60° is a limit; treat it as such or you may find yourself suddenly in a situation you cannot handle. How often do you drive your car to its limits? Why treat your aircraft any differently.
