SERVICE BULLETIN NO.29 - 27th June,1988 - Circulation - all owners.

The Bedford Fatality. - Two people were killed outright on a 1984 Gemini Flash and evidence points to the front strut separating in flight allowing the trike unit to swing backwards bending and breaking the monopole, destranding and breaking the internal wire and allowing the cockpit and occupants to fall 1000' to the ground.

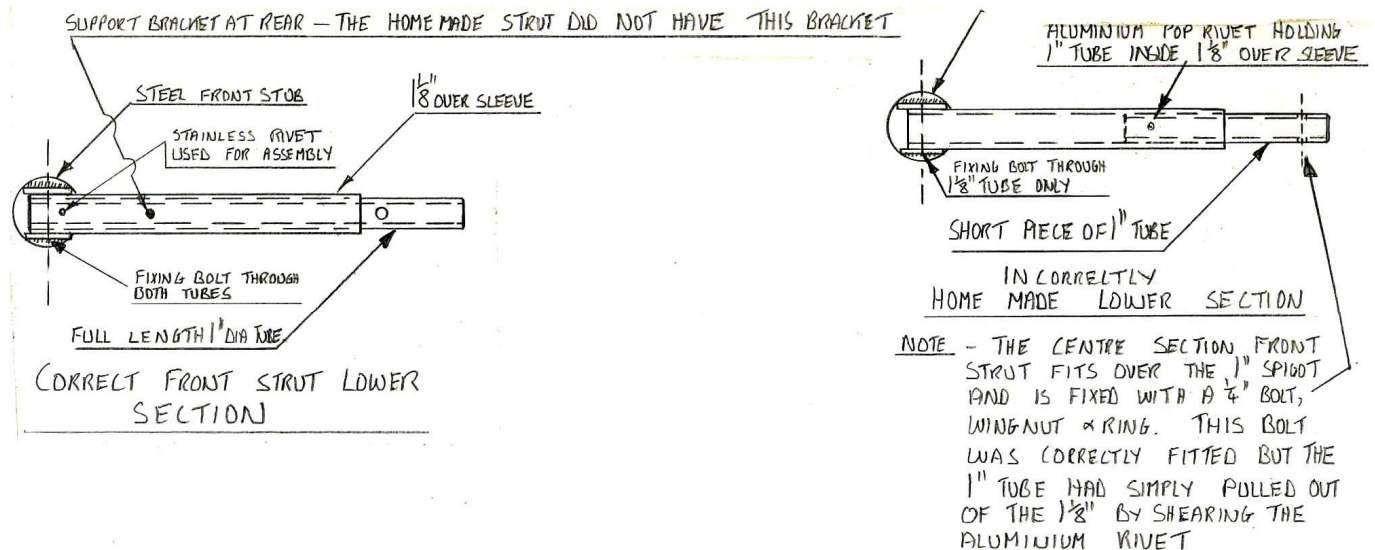
I was asked to visit the AIB at Farnborough to inspect the wreckage and discovered that all pieces of the three section front strut had been home made, not one was the correct length nor drilled or sleeved correctly. The bottom 1" section to which the centre section is fitted with a 1/4" bolt was fitted into the 1 1/8" outer tube by only 3", was made from a piece of non standard thickness tube and was held with a single 1/8" aluminium pop rivet instead of being full length and integrally fitted to the steel stub fixing bolt.

- C). The front strut assembly should be carefully inspected and worn or elongated holes and deep chaffing will call for replacement of the part with Mainair factory issue components only. Slight chaffing is expected and acceptable where the 1 1/8" sleeve slides over the 1". The bottom section is made from a 1" tube with a 1 1/8" oversleeve and the 1" tube should be full length and exit from the bottom where it is fixed to the stub. - ensure the continuity of this tube - see drawing below.

- A). No owner should fit a non-factory produced part to his aircraft unless the producer has our full authority to manufacture such a part.
- B). All owners of used aircraft should carry out a detailed inspection of all structural components of their aircraft paying particular attention to the front strut, monopole, keel, undercarriage, wing keel, control frame, cross tubes, leading edges and all other components looking for evidence of replacement IE, mis-matched anodising, holes drilled but not used, aluminium pop rivets (we only ever use 1/8" stainless steel or 3/16" and 1/4" monobolts) etc. If you are not qualified to do this, then find someone who is.

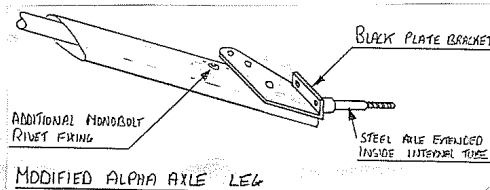
Microlights continue to be crashed hard into the ground owing to pilot error, frequently by low hour/experienced pilots or students. All metal structures have a limit at which things break and we have recently had evidence of the limits of the Alpha axle assembly. When the springs are bottomed (600 plus kg) and the load continues to be applied, something has to break and we have discovered that the first thing to go is the internal round tube into which the axle is fitted. Because at the time the axles are splayed well out with the tyres flattening increasing drag loads, the internal tube can break on the front side allowing the axle stub to rotate outwards dramatically increasing the drag loads and in severe circumstances tearing out the drag link causing loss of the undercarriage.

Modified axles can be identified by a monobolt fixing just beyond the black aluminium plate bracket to which the spat and struts are attached - see drawing.

On Gemini trikes, the front strut would break, the seat frame would fail or the keel bend. The Alpha suspension absorbs all this load and puts it somewhere else but we consider it prudent that a seat frame/keel failure is better than an undercarriage loss. We have therefore modified the axle attachment to prevent rotation at overload and this can be carried out on any aircraft if so desired. In addition the drag links have an additional strengthening sleeve at the end fixing. It is necessary for the machine or rear axles and drag links to be returned to the factory for this work which takes about 4 hours. We emphasise that this is a precautionary modification only and is a means of preventing more serious damage in a crash or very hard landing situation. The work will be carried out at a cost price of £50.00.
