Service Bulletin No: 43
Issue: 2
Date: 20th June 2000

Applicability: Gemini Flash 2, Gemini Flash 2 Alpha & Mainair Mercury

CAA Classification: Mandatory

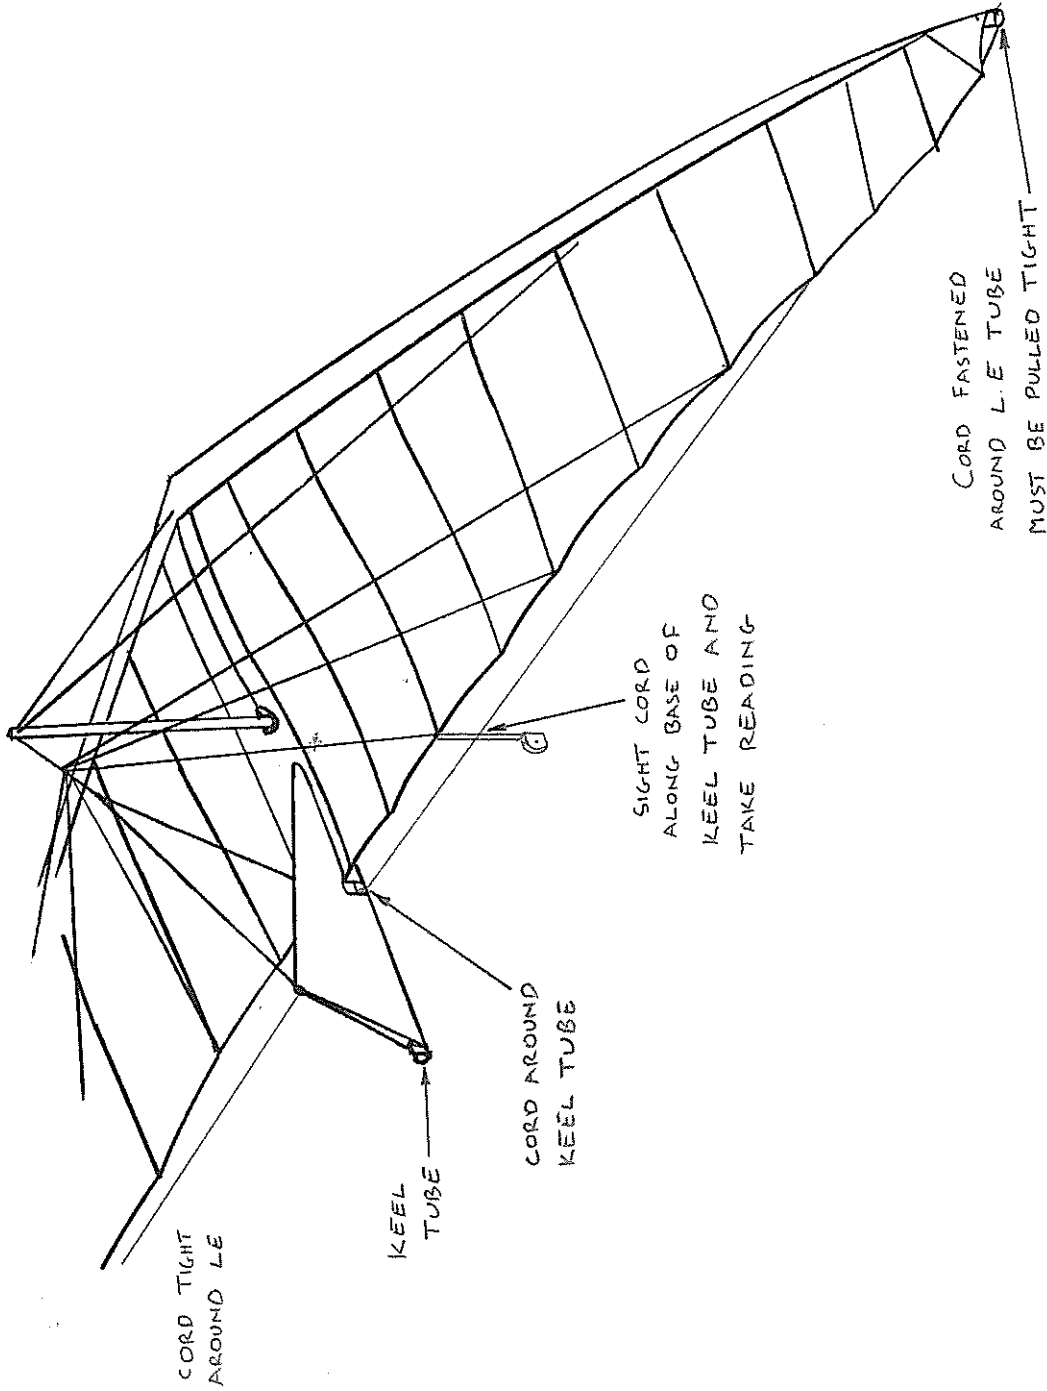
DWG NO. FGA-77

Leech Lines: These must be set to within the limits as shown on the attached sheet. These can only be measured with the wing rigged, and after the batten profiles have been checked. The method for measuring these is to tie some string around the wing tip and routing beneath the wing sail towards the keel. This must then be pulled tight to remove all slack and looped around the keel, from beneath, at the front of the fin, and then carried onto the other wing tip where it must be tied off. As indicated on the enclosed diagram. The wing must be approximately level. Using a retractable tape, the settings can be measured by hooking the tape over the trailing edge of the wing at the leech line in question and sighting the string in-line with the bottom of the keel. The reading from the tape must be taken and the corresponding reading from the other side of the wing must also be measured and the average

calculated. This gives the setting for the leech line. This must be checked against the range as indicated on the attached sheet. All three leech lines must be measured and compared to the required readings. Adjustments can be made by altering the settings using the seven hole adjuster near the king post. Remember that altering one line can affect the other settings so all three will require measuring again. If the settings cannot be made to match the correct figures then the factory must be consulted, for advise.
