Date. 27th April 1987.

SERVICE AND OPERATIONAL INFORMATION.

SUBJECT: Rotax 447 and 462 Exhaust Systems.

<u>MODELS AFFECTED:</u>	<u>SERIAL Nos AFFECTED</u>
PEGASUS XL-R	ALL SERIAL No.s
PEGASUS FLASH	"
PEGASUS FLASH 2.	"

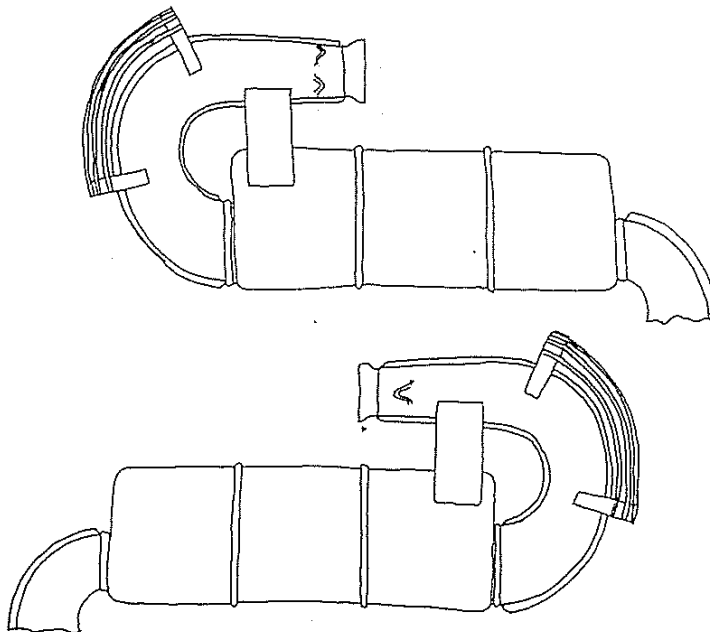
Operators who have experienced exhaust cracking are requested to mark the diagram below where the crack occurred and return the diagram to:
